MEYLE
Products®

Steering coupling

MEYLE No. 7147250001/HD
Reference No. 7257202

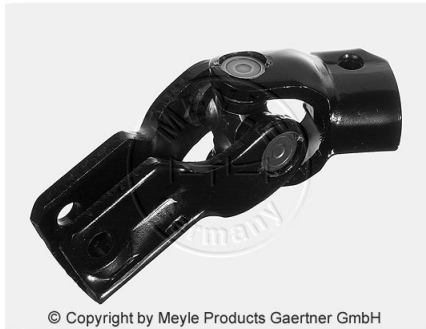
The Ford steering coupling has drawn attention through its failure frequency. Although the rotating joints are lubricated and sealed, moisture seeps in after a short working life. Corrosion destroys the joint.

When driving in the rain, water is sprayed on to the steering coupling from the front wheel at a high speed. This hard water jet washes the grease from the steering coupling; the seal cannot withstand the water jet and moisture seeps into the clutch bearing.

Our aim was to protect the joint against the direct water jet. A shielding plate is extremely difficult to fit; complete metal-cladding is too costly. We have designed a rubber sealing ring that protects the joint against the hard water jet. Water may penetrate the sealing ring, but it comes out again through the lower opening. The grease and the seal are therefore protected against the spray jet and the steering coupling no longer breaks down.

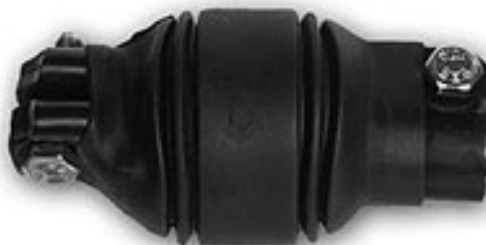
Rubber sealing ring
